## **Limited Visual Dam Safety Inspections**

**OA00018**

**Opaepala 01 Reservoir**

**May 2006**

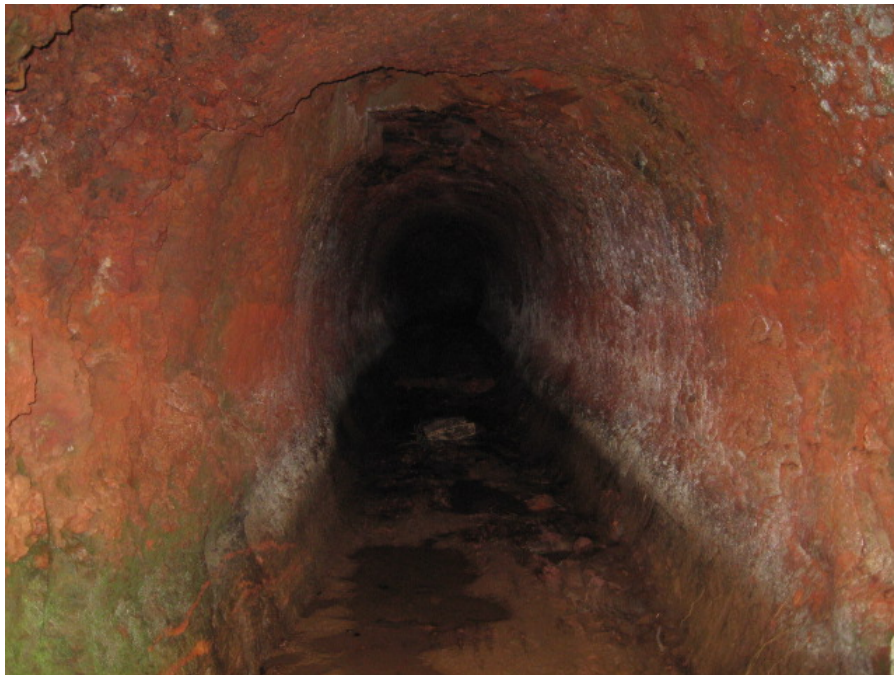
This spillway consisted of a tunnel in rock with a concrete entrance near the left abutment. The outlet of the spillway was not observed.

**Photo 1 Spillway tunnel.**

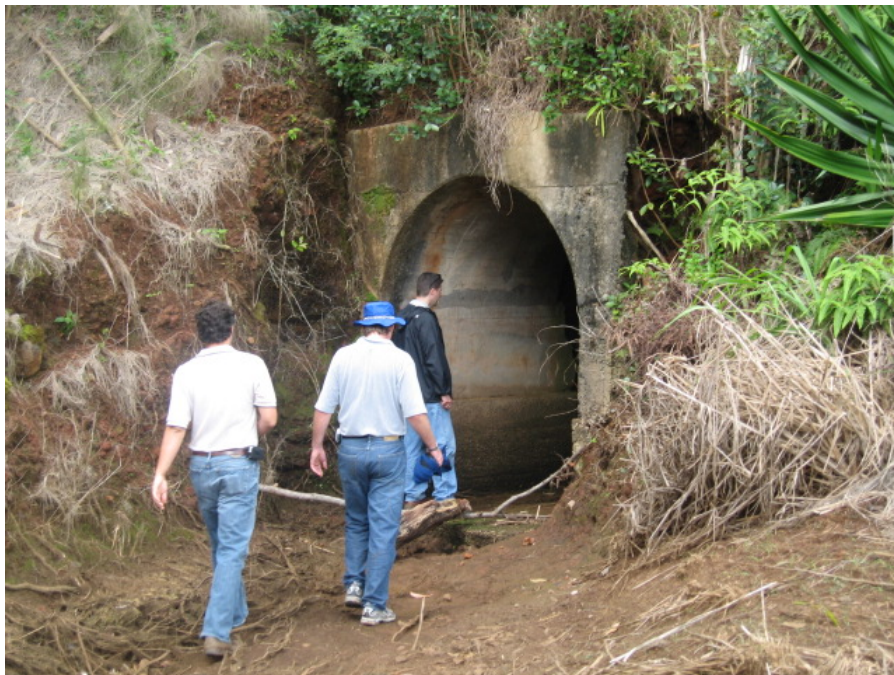
**Photo 2 Spillway tunnel entrance.**

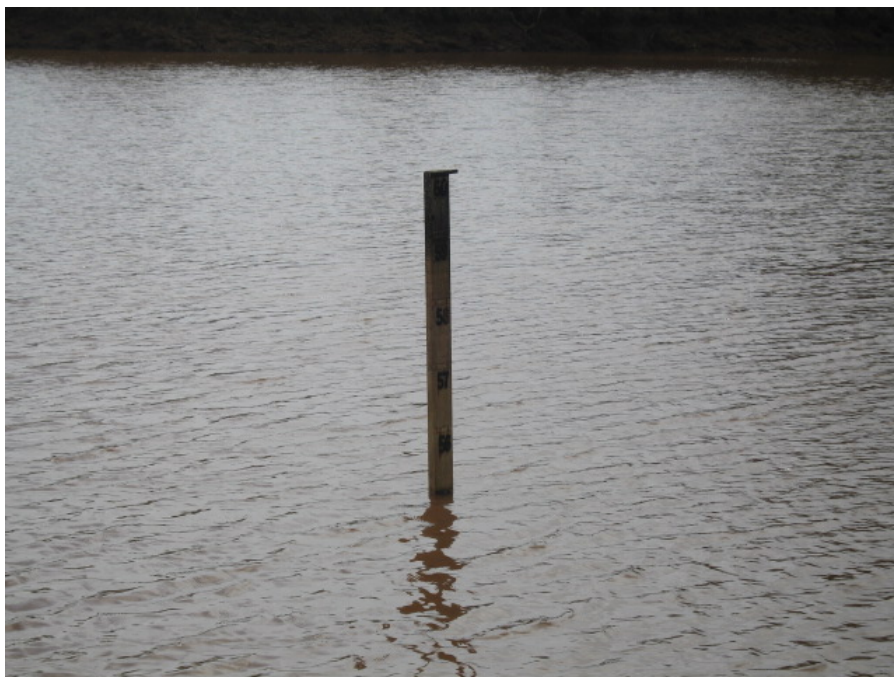
A staff gage was observed near the left side of the reservoir.

**Photo 3 Staff gage.**

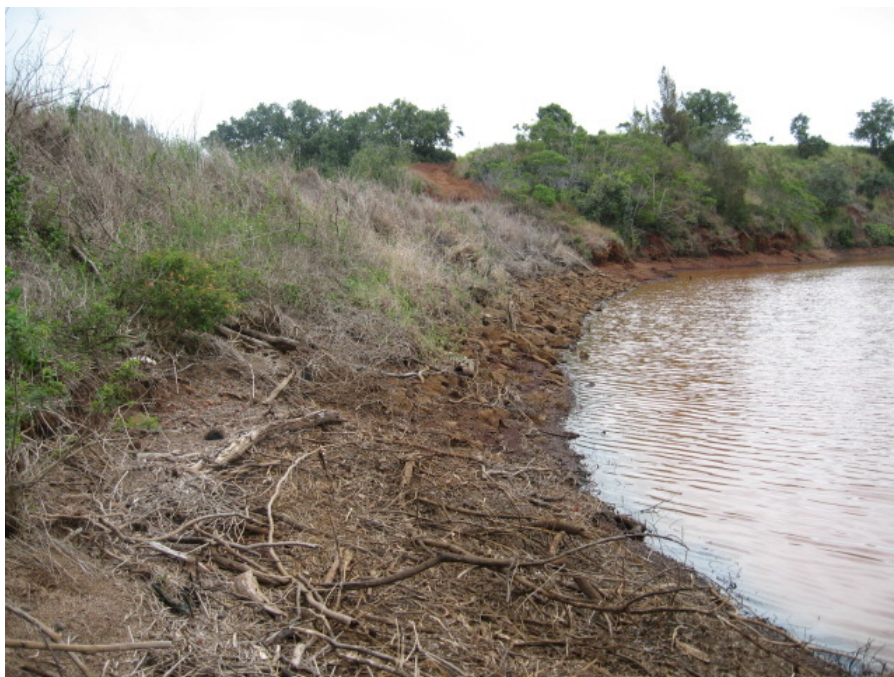
A dumped rock slope protection was observed. Little vegetation was observed growing between the rocks.

Erosion was observed on right side of dam near abutment.

- a. The upstream slope appeared to be in fair to poor condition and requires corrective action.
- b. Rut and/or Gully erosion was observed on the slope, which requires maintenance and/or repair. Description: Fill and compact gully.
- c. Tree(s) were observed on the dam embankment. Trees have been identified as the probably cause of piping failures, and can possibly cause severe damage to the embankment if they are uprooted during a high winds. Corrective action is required to remove the tree hazards from the dam. Acceptable remedies include removal of the tree and its root structure down to a 2" diameter and

**Photo 4 Upstream slope.**

reconstructing the damaged embankment section. All repair work shall be accomplished as per the requirements of licensed geotechnical or structural engineer.

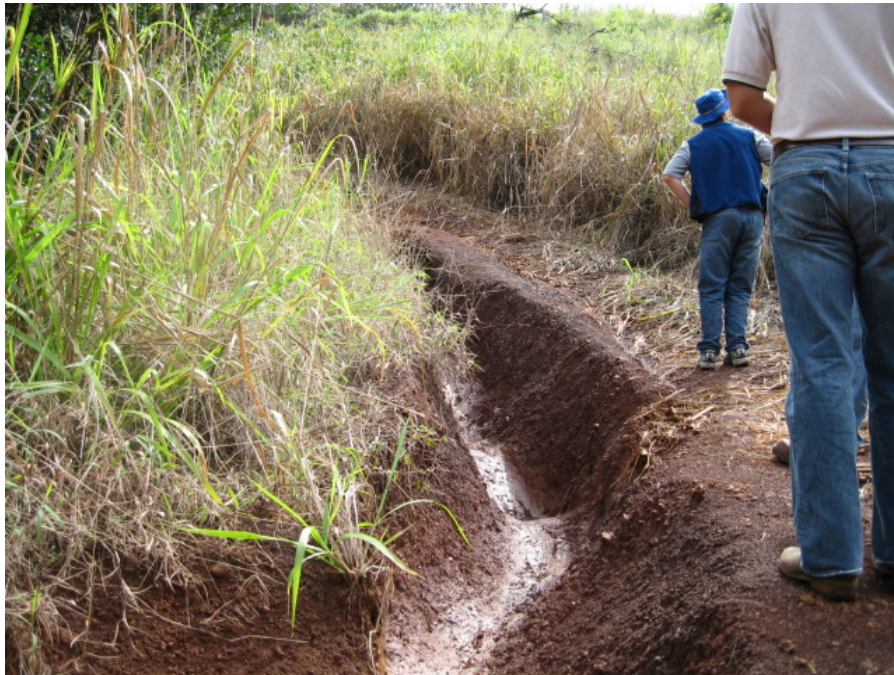
Erosion was observed on the downstream walking path and no erosion was observed on the downstream slope.

- a. The downstream slope appeared to be in fair to poor condition and requires corrective action.
- b. Rut and/or Gully erosion was observed on the slope, which requires maintenance and/or repair. Description: Repair gully on access path by filling, compacting, and regrading. If not corrected could be problematic.
- c. The down stream slope was not visible due to high grass and bush vegetation. Clear high vegetation and maintain low to enable easy visual inspection.
- d. Tree(s) were observed on the downstream slope. Trees have been identified as the probably cause of piping failures, and can possibly cause severe damage to the embankment if they are uprooted during a high winds. Corrective action is

**Photo 5 Downstream access road erosion.**

required to remove the tree hazards from the dam. Acceptable remedies include removal of the tree and its root structure down to a 2" diameter and reconstructing the damaged embankment section. All repair work shall be accomplished as per the requirements of licensed geotechnical or structural engineer. Routinely monitor the damaged area for signs of settlement and seepage.

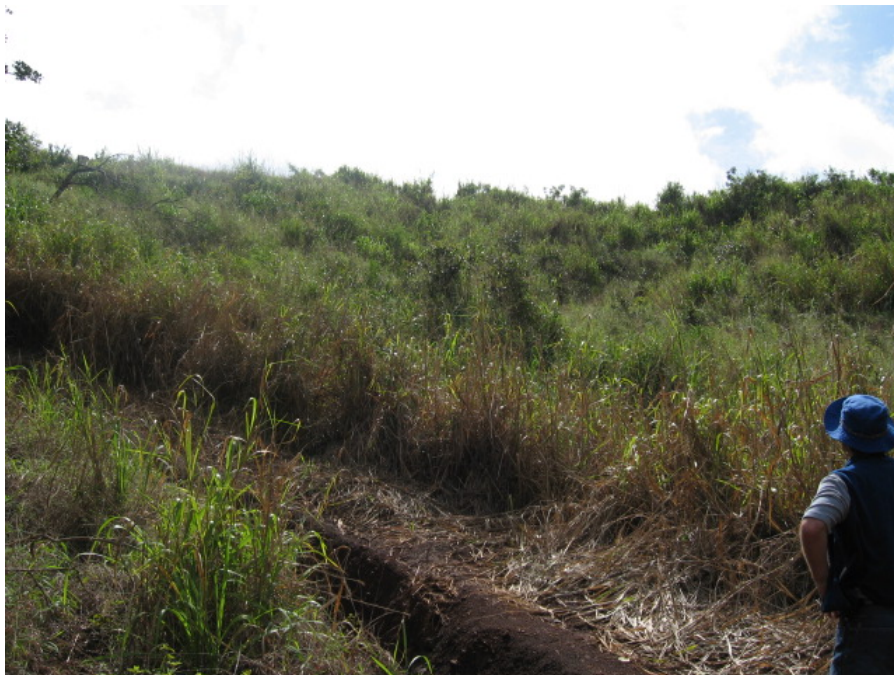
The downstream slope was in fair condition with some high grass and a few trees.

Vegetation was observed on the downstream slope. The majority of the vegetation was high grass with a few woody trees less than 6" in diameter.

**Photo 6 Downstream slope.**

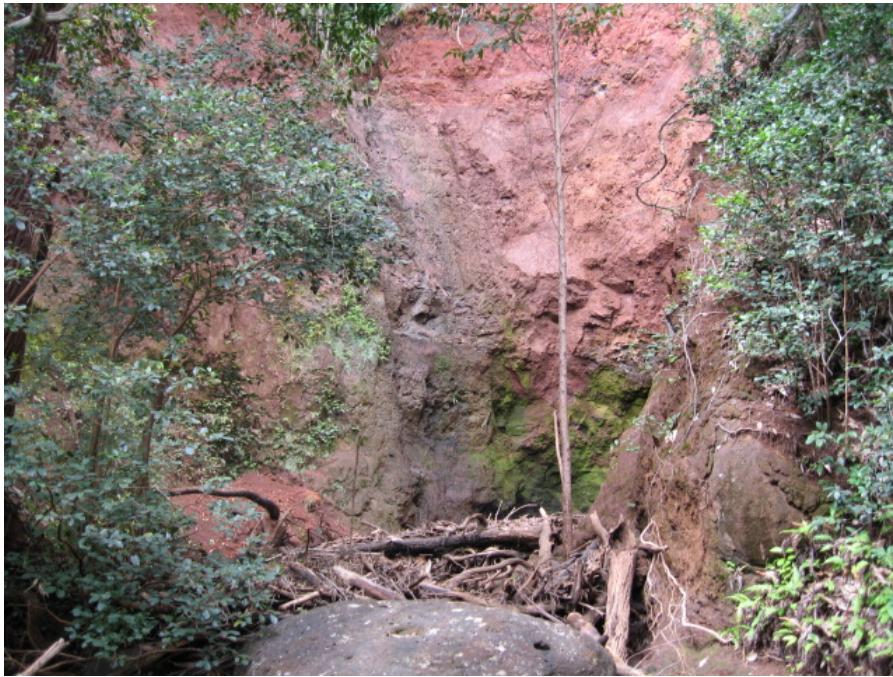
There was erosion observed near the spillway where it plunges into a pool. It is approximately a 50 ft plunge into the pool.

- a. The Spillway appeared to be in fair to poor condition and requires corrective action.
- b. A headcut was observed downstream of the spillway. Corrective / mitigative action is required to prevent this problem from moving upstream.
- c. Trees are unacceptable in the spillway channel and approach. Take corrective action to address the woody vegetation problem and repair the damaged area.
- d. Unclear if spillway is adequately sized. Spillway should pass the probable maximum flood. Verify spillway capacity and take corrective action as required.
- e. Monitor spillway plunge pool to ensure erosion does not damage spillway exit.

**Photo 7 Spillway plunge pool.**

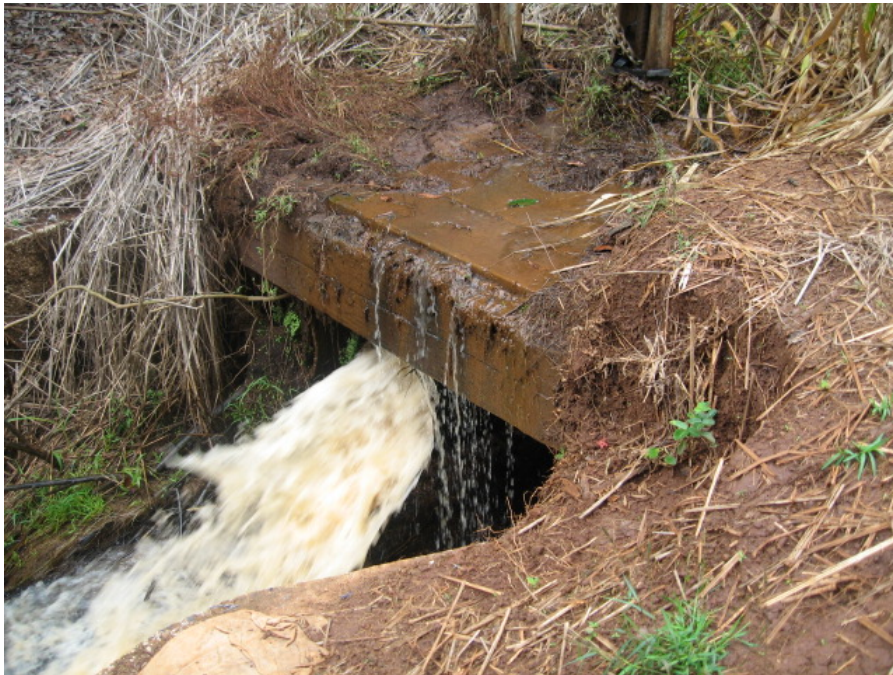
- a. The outlet works were not tested.
- b. The outlet works appeared to be in fair to poor condition and requires corrective action.
- c. Suggest repairing unused valve and pipe to have a back-up if main fails. Back-up may also be needed in emergency situation.

**Photo 8 Outlet pipes.**

- ☒ i. Repair unused valve and pipe, if main fails could be problematic backup could be needed in emergency situation.
- ☐ j. \_\_\_\_\_

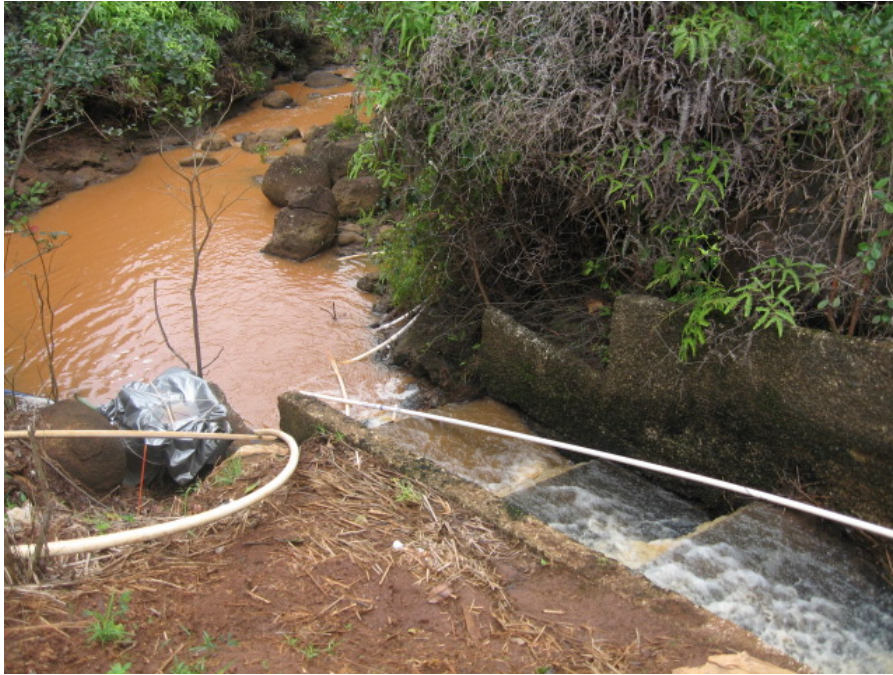
**Photo 9 Outlet channel.**

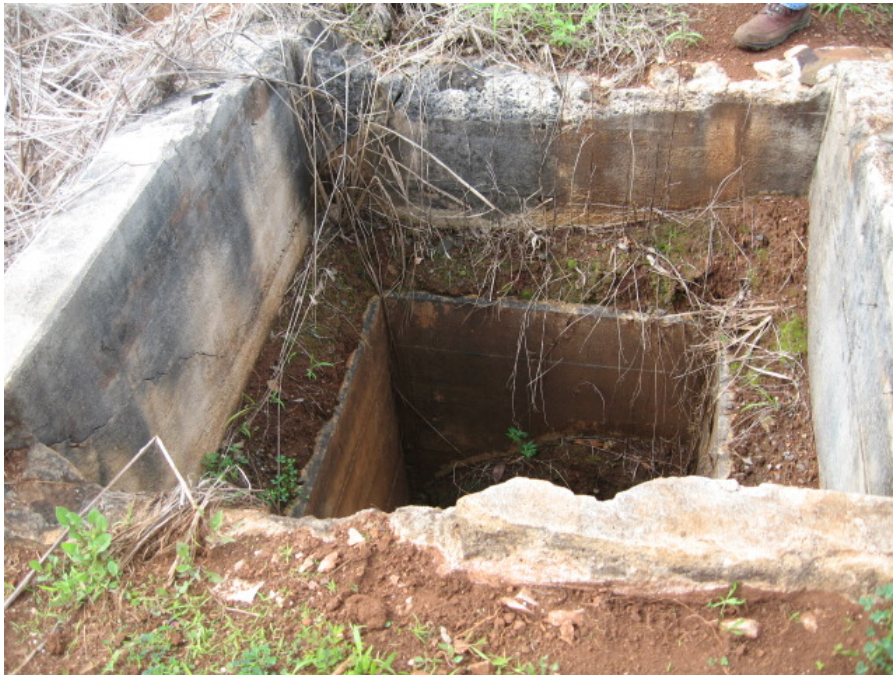
**Photo 10 Access pit at top of dam.**

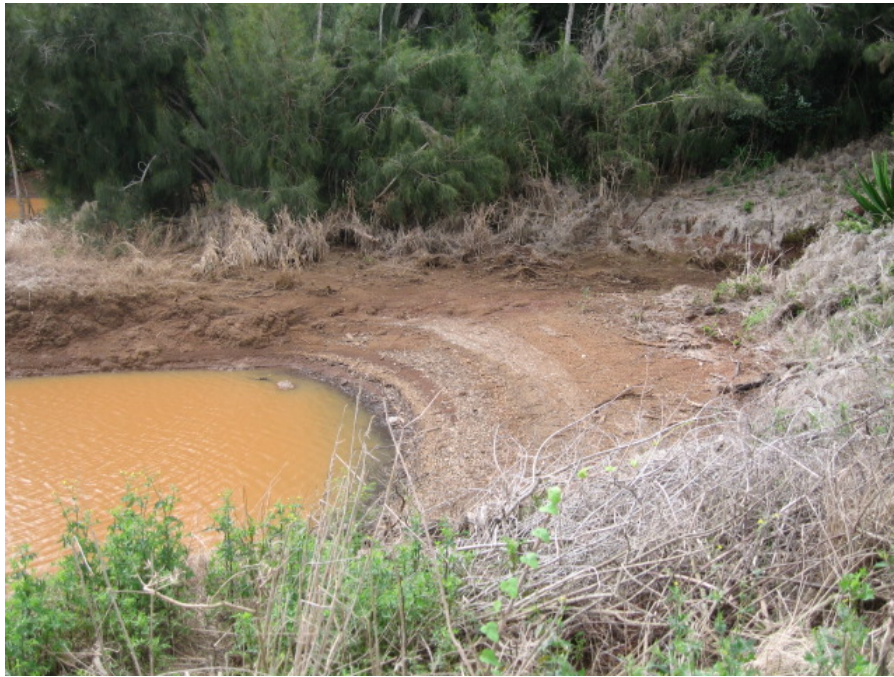
**Photo 11 Spillway entrance, trees need to cleared.**

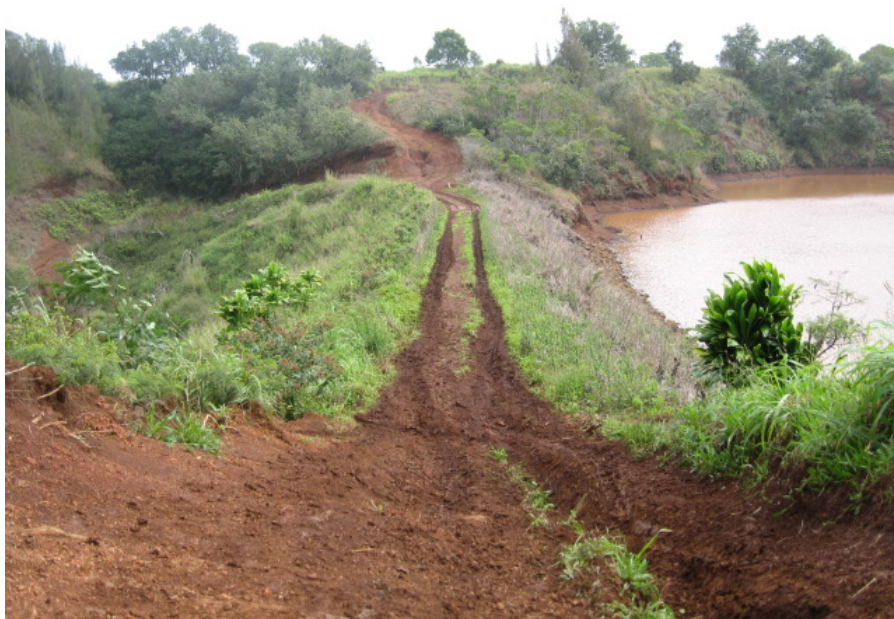
An erosion gully was observed at the entrance to the crest on the left site of the dam.

- a. The dam crest appeared to be in fair to poor condition and requires corrective action.
- b. Access along the crest was satisfactory.
- c. Rut and/or Gully erosion was observed on the crest, which requires maintenance and/or repair. Description: Fill and compact gully. Grade surrounding area to drain without erosion.

**Photo 12 Dam crest, erosion gully on access road.**

Also please comment to the owner about the erosion at the entrance to crest. Should it be corrected immediately (within 6 months)? **It is recommended that the erosion at the crest be repaired within 6 months.**

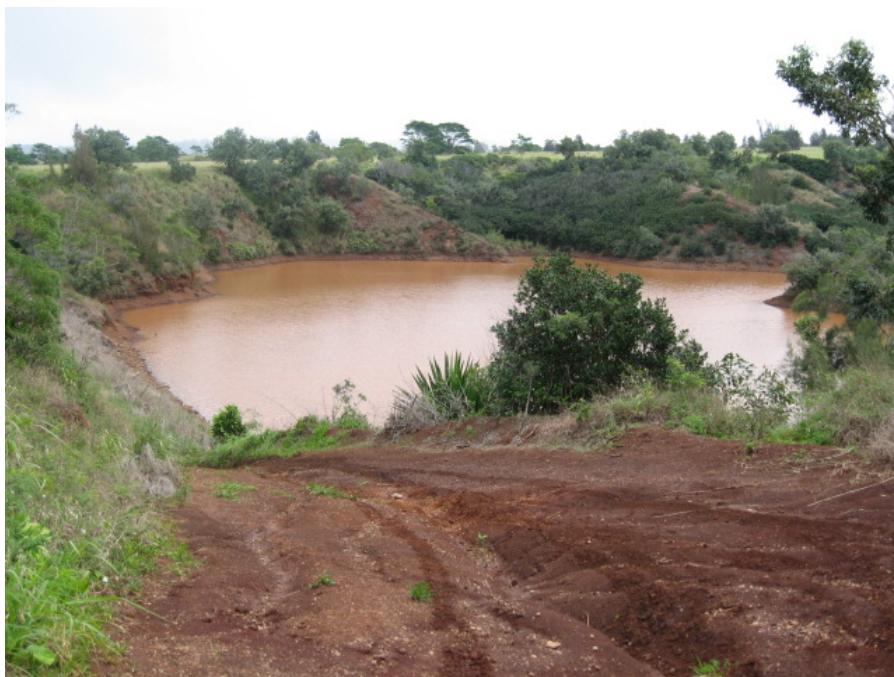
**Photo 13 Reservoir overview.**
